USING IN-HOUSE RAPID QUALITY CONTROL EQUIPMENT TO REVEAL MORPHINE AMPOULE TAMPERING -A CASE REPORT

Baghdarsarian, R¹, Hellström, K¹, Paulsson, M^{2*}

¹ Uppsala University Hospital Compounding Unit, CU

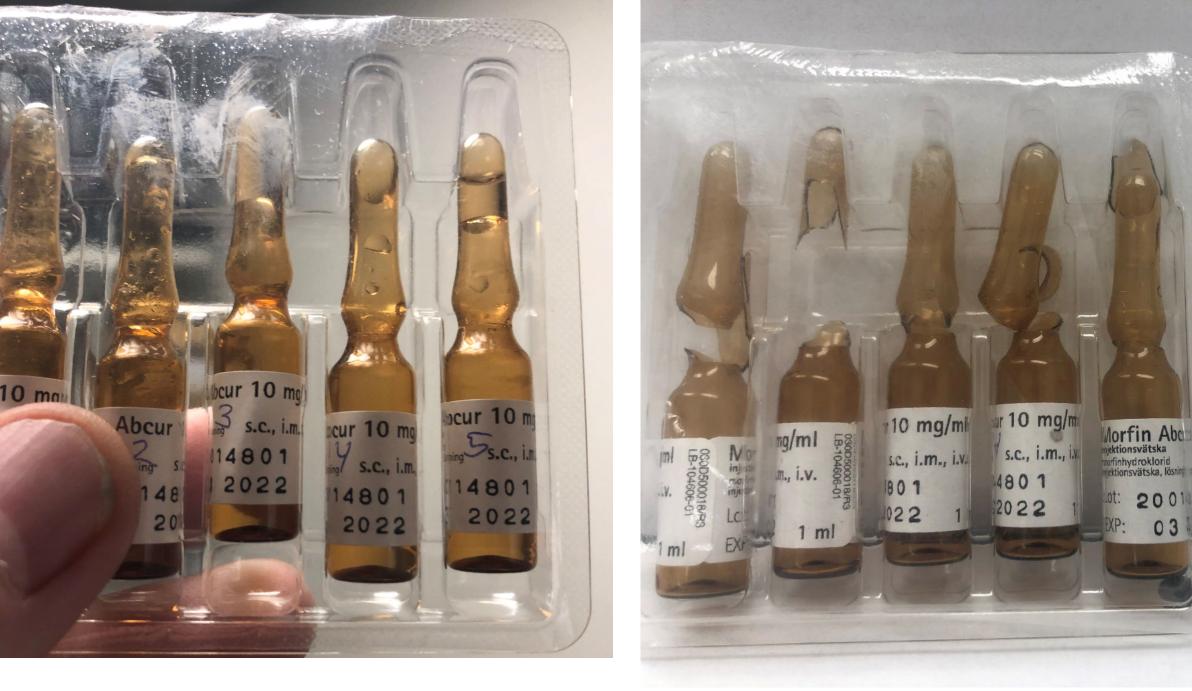
The health care professionals (HCPs) at the Paediatric Emergency Ward suspected that morphine glass ampoules had been manipulated. They discovered that the seal of the outer packaging was broken and when snapping the vials open, the vials would break in an unusual and uneven way (Figure 1B). Simultaneously, the HCPs discovered that one of the paediatric patients had not received the anticipated analgesic effect of the ordered morphine infusion (Figure 2, Sample S1 in Table 1).

Figure 1. Morphine (Morfin Abcur 10 mg/mL) glass ampoules. Before (A) and after (B) opening.

The results showed that all ampoules had been emptied from its labelled contents and likely refilled with Sodium Chloride 9 mg/mL. The infusion solution given to patient was also likely prepared from a tampered ampoule. These results were crucial information in the conversation with parents about the incident, and the subsequent report to the police regarding the probable violence offence.

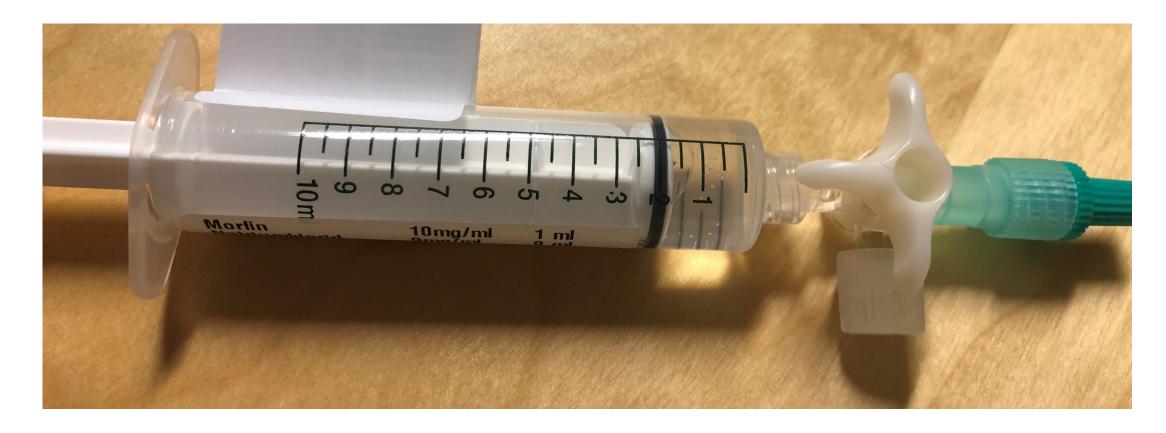
An easy-to-use spectrophotometer [1] at the CU was within hours adapted to be utilized for morphine analyses. The results clearly show that the infusion labelled 10 mg/mL was tampered with, containing only 0,4 mg/mL morphine. As the ward also uses morphine oral mixture 2 mg/ml, this was analysed as well and found tampered with at two occasions. One Midazolam oral solution product was also analysed but no signs of tampering could be seen.

Figure 2. Morphine syringe administered to patient (sample S1).
